## Factory-Built Grease Duct

### New Code, Historic Downtown Building How Restaurant Rehab Incorporates Factory- and Field-Fabricated Grease Duct to Solve Code and Space Issues.

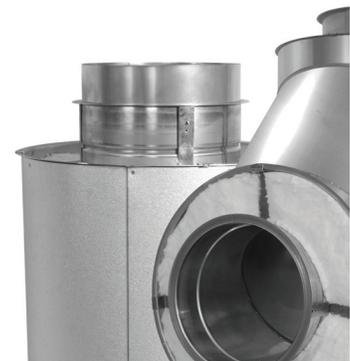
Factory-built grease duct eliminates most, if not all, of job site welding. The systems are modular in design and easily assembled. Instead of welding, components fit together with bands and are made liquid-tight by use of a special sealant. Factory-built systems also include leak-proof, fire-tight access doors, which are required

for regular duct cleaning but are often improperly installed or omitted in field-welded systems.

The DuraVent zero clearance (UL 2221 Listed) grease duct that was selected for the Yorgos project is double-wall stainless steel and ships pre-insulated from the factory, so no additional fire wrap is required to achieve its two-hour fire rating. The product is certified to UL 1978 “Grease Ducts for Restaurant Cooking Appliances” and UL 2221 “Standard for Tests of Fire Resistive Grease Duct Enclosure Assemblies.” DuraVent grease duct also includes a unique centering sleeve that stabilizes the tubes during assembly and covers joint grooves that might otherwise trap grease contaminants. This sleeve offers additional support during installation, and often requires less manpower to hold the duct in position while the sealant is applied.

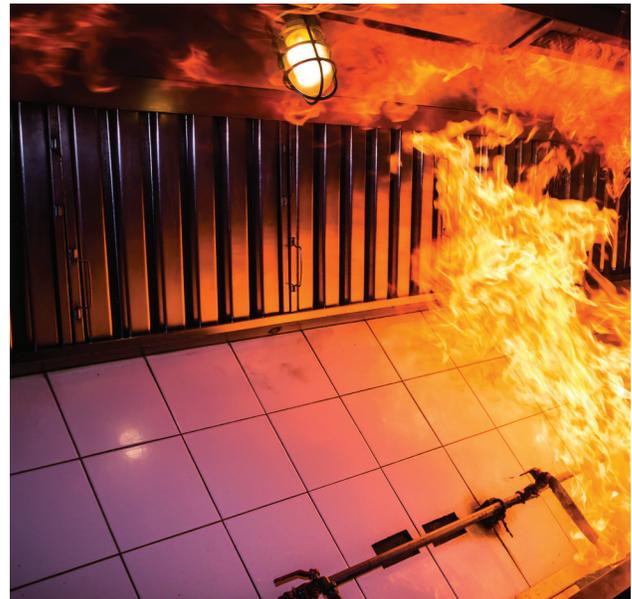
Services, Inc., the mechanical contractor, to design transitional pieces between the factory-built duct and a limited amount of field-welded rectangular duct, which can be constructed with a lower profile. Ordinarily field-welded duct would not be allowed in a new or renovated Lancaster building because of the previously mentioned ordinance. However, because making the round duct fit in certain areas of the basement and above the top floor ceiling would involve extensive structural modifications to the building, the construction team (with the help of the third-party inspector) sought and was granted permission from the City of Lancaster to install limited runs of field-weld duct.

Clark fabricated the transitional pieces in its shop according to DuraVent’s design, along with the necessary rectangular sections of duct. All the duct
